February 8, 2019

Re: Sunny Farms Landfill LLC  
Notice of Violation (NOV)  
NOV  
Municipal Solid Waste Landfills  
Seneca County  
MSWL018786

**Subject: Notice of Violation**

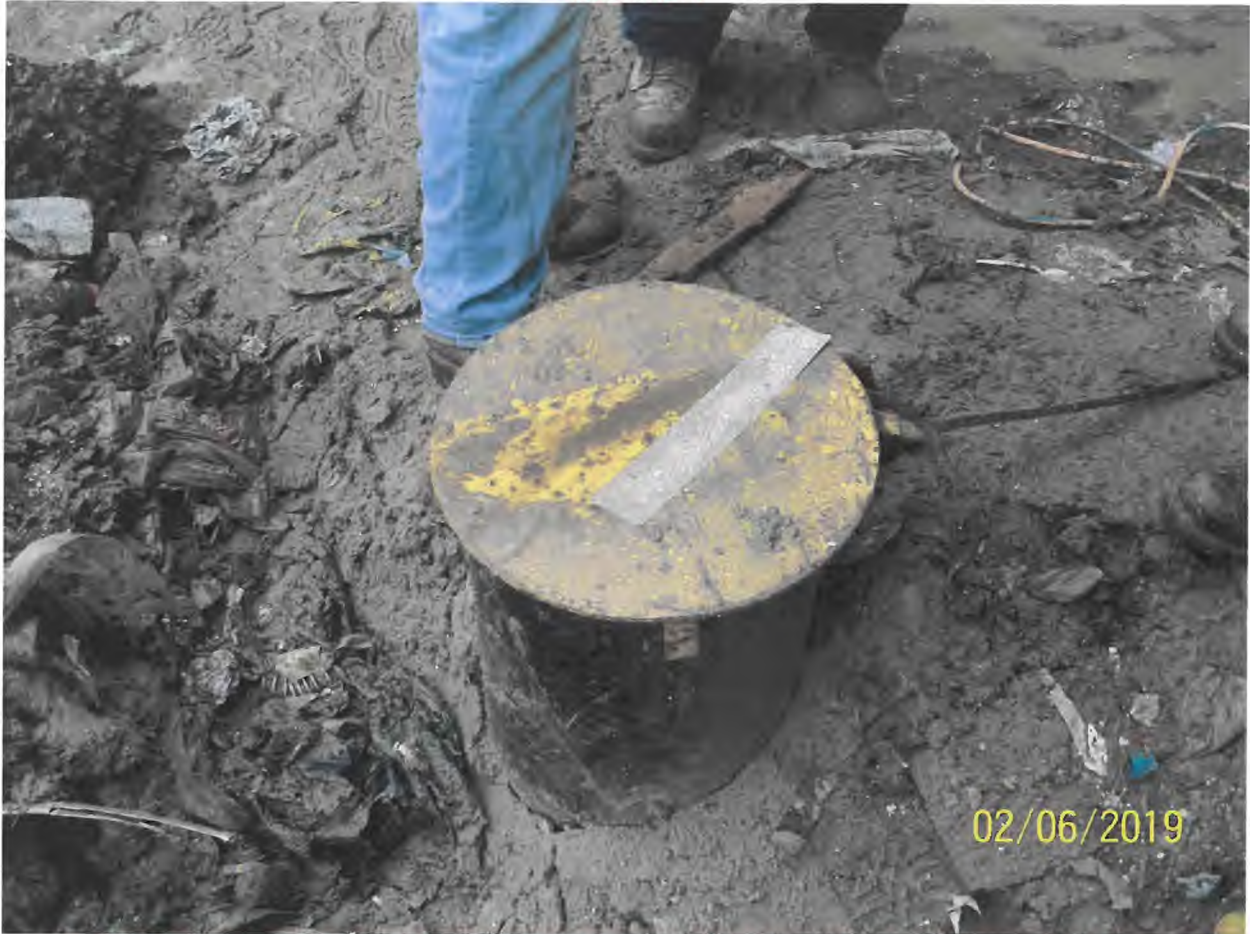
(a) **Description:** Ohio EPA identified an unauthorized sump that collected leachate near the rail unloading building. The sump was located just outside of the rail unloading building at the northeast corner of the building. The sump contained an electric pump. Attached to the pump was a hose that was buried underground and ran underneath the railroad tracks to the east and terminated into the pond east of the rail unloading building. During the inspection, a representative of the landfill noted that the hose in the past ran above ground but was buried this past summer. See attached photographs and photograph descriptions.

(b) **Further information:** Ohio EPA has determined that the owner/operator of Sunny Farms Landfill has not disposed of collected leachate properly.

- 1) Capped riser pipe located at the northeast corner of the rail unloading building which housed the pump and flexible discharge house.

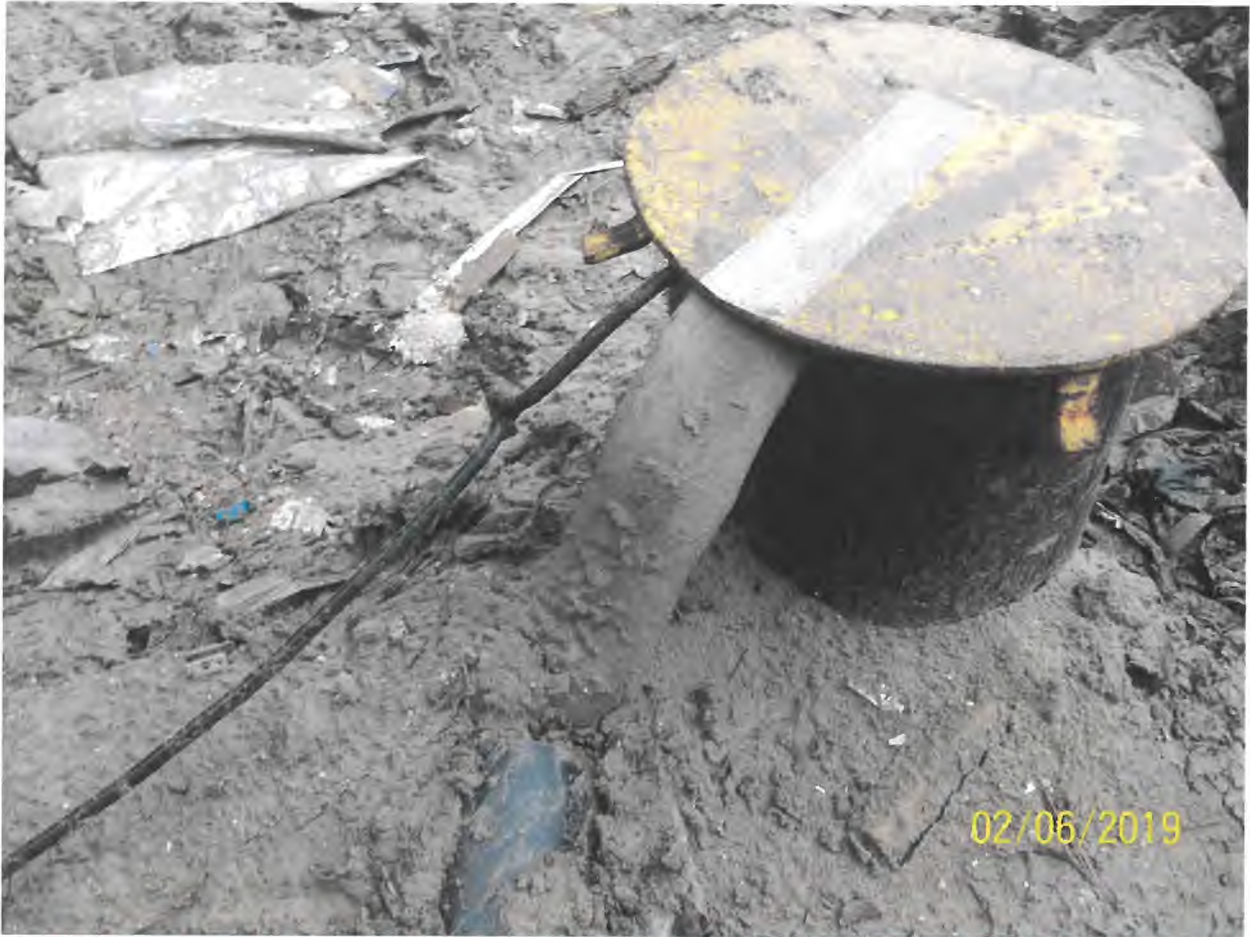
- 2) Capped riser pipe located at the northeast corner of the rail unloading building. Power cord, flexible hose, and edge of the hard pipe that continues under the tracks are displayed.

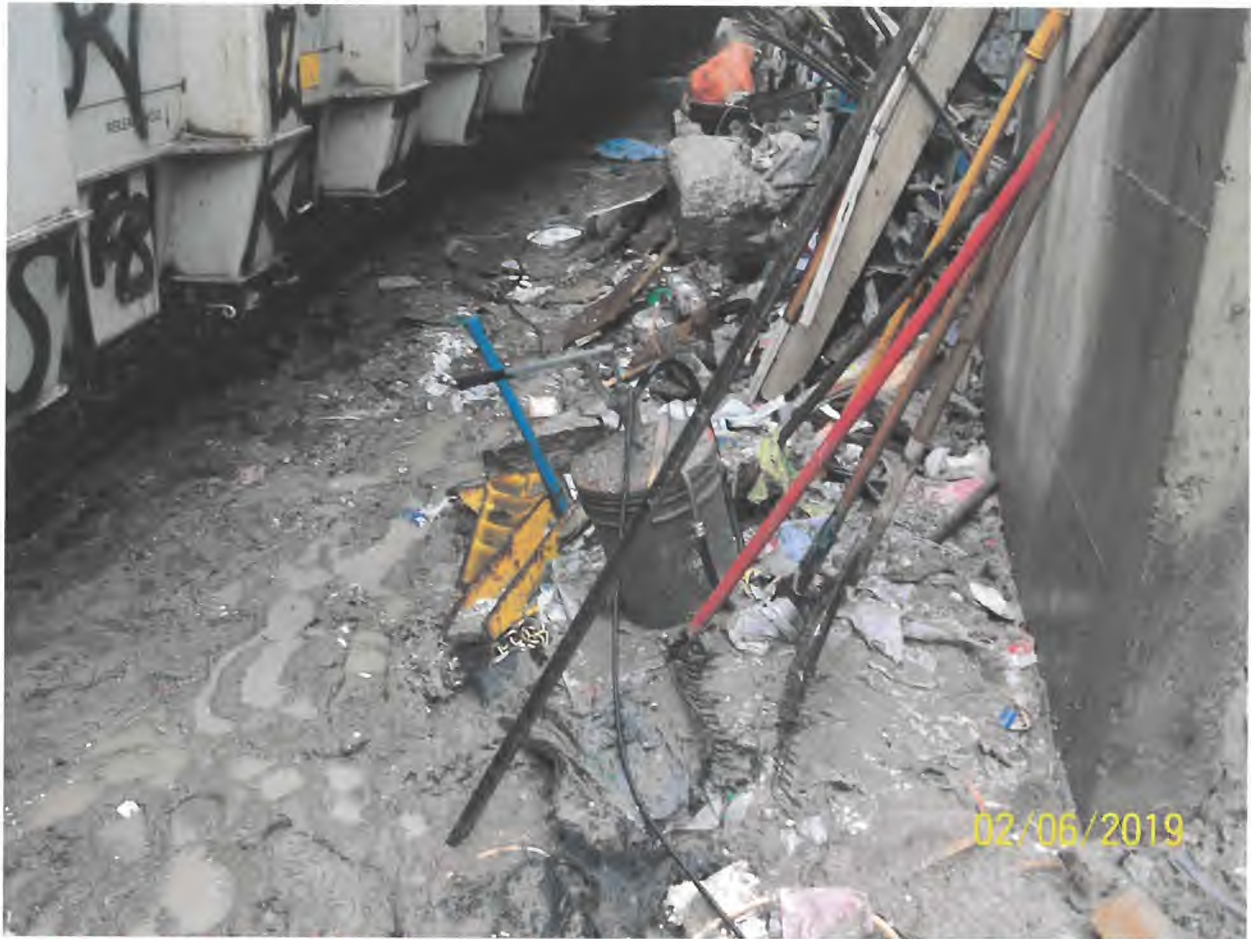
(a) **Description:** Ohio EPA noted an unacceptable amount of scattered litter around the rail unloading building, and in the pond east of the rail unloading building. The owner/operator needs to take additional measures to collect and contain scattered litter and debris that is currently not being contained within the rail unloading building. See attached photographs and photograph descriptions.

- 3) View looking south from the capped riser pipe. The black power cord can be seen running along the east edge of the rail unloading building. Litter and debris in this photograph are indicative of the litter and debris strewn throughout the entire area.

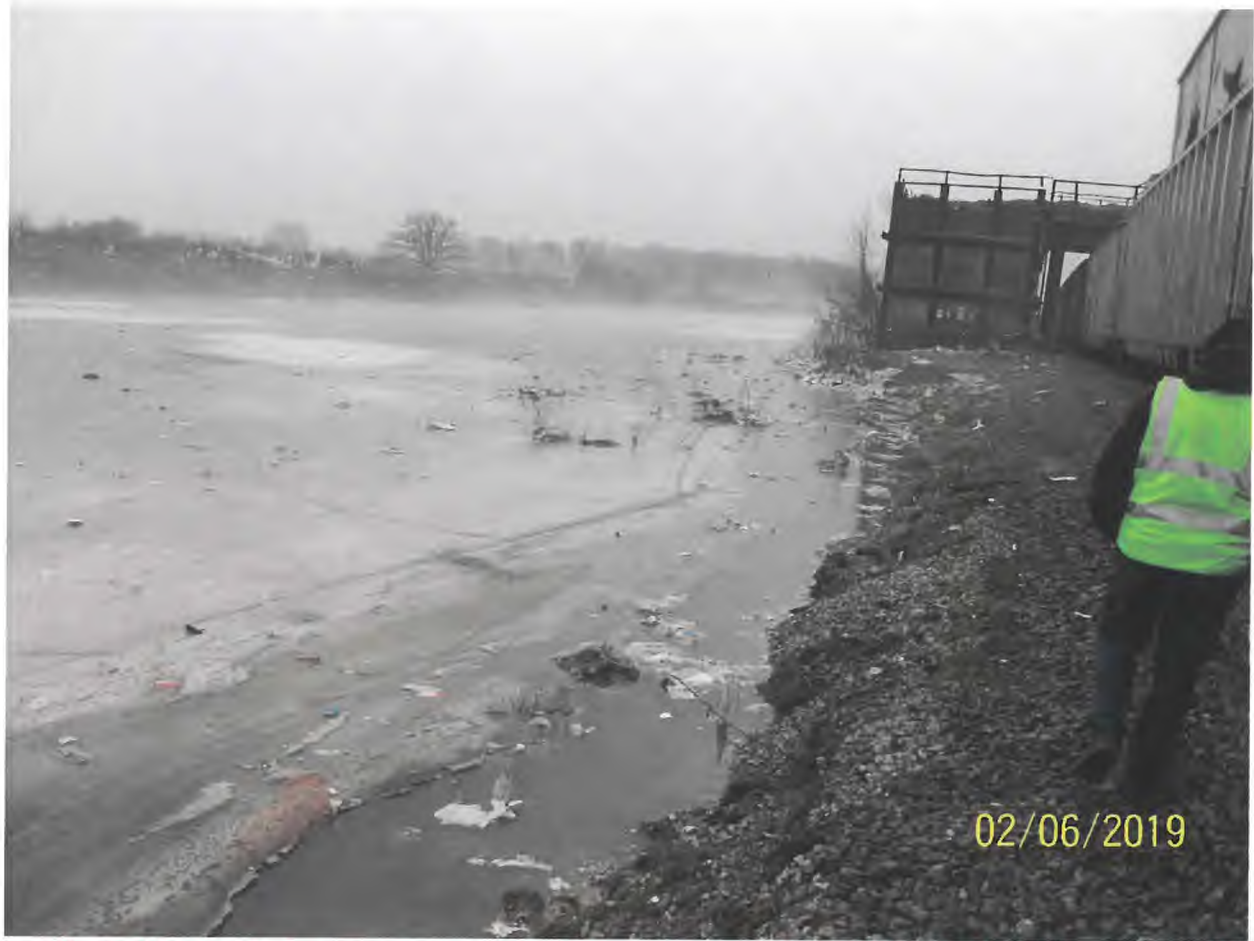
- 4) Looking south along the western edge of the east pond. The outlet end of the drain pipe is in the distance amidst the excessive litter and debris that has collected in the pond.

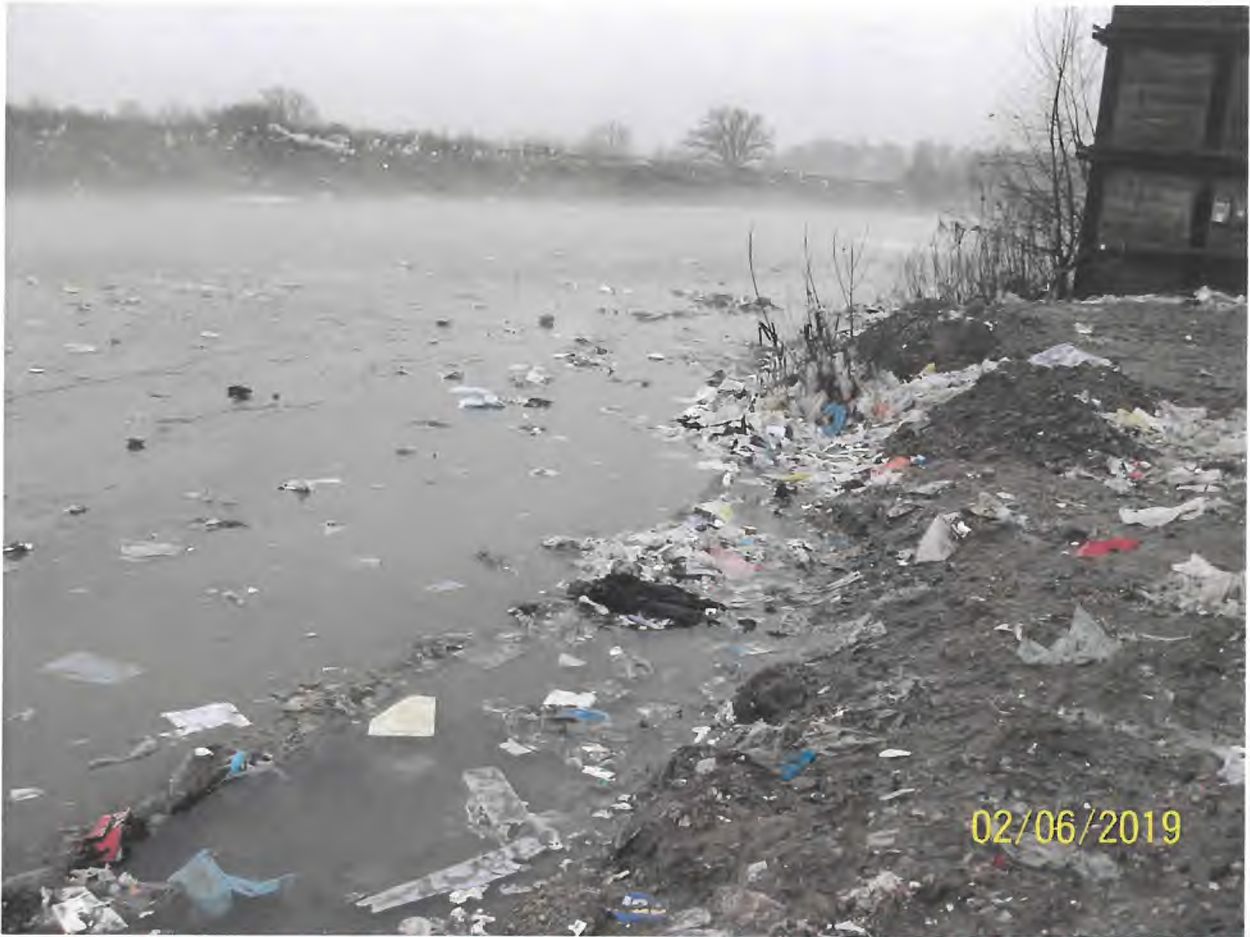
5) Looking south along the western edge of the east pond. The outlet end of the drain pipe is in the midst of the excessive litter and debris that has collected in the pond.

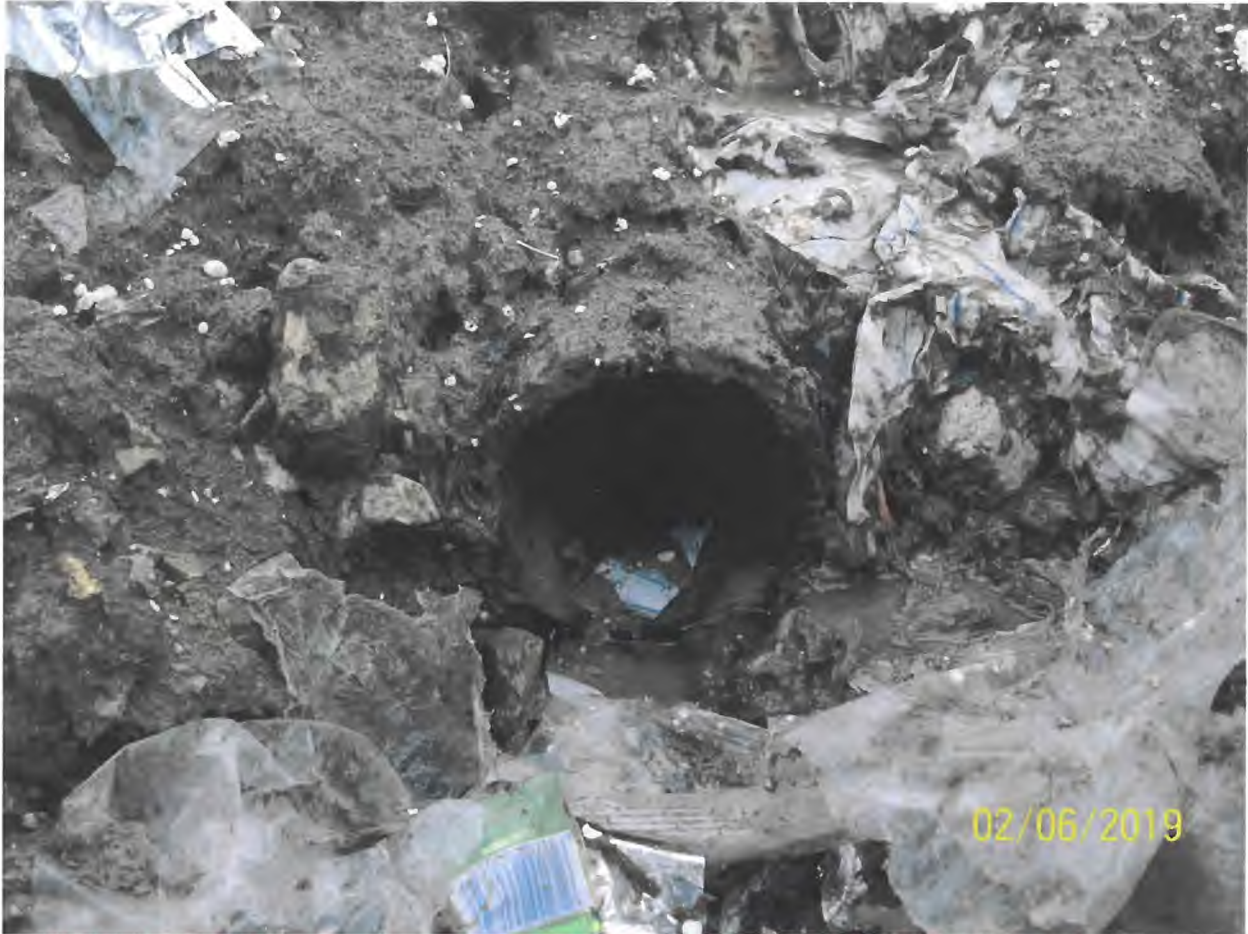
6) Outlet end of the drain pipe as it daylights along the western edge of the east pond.

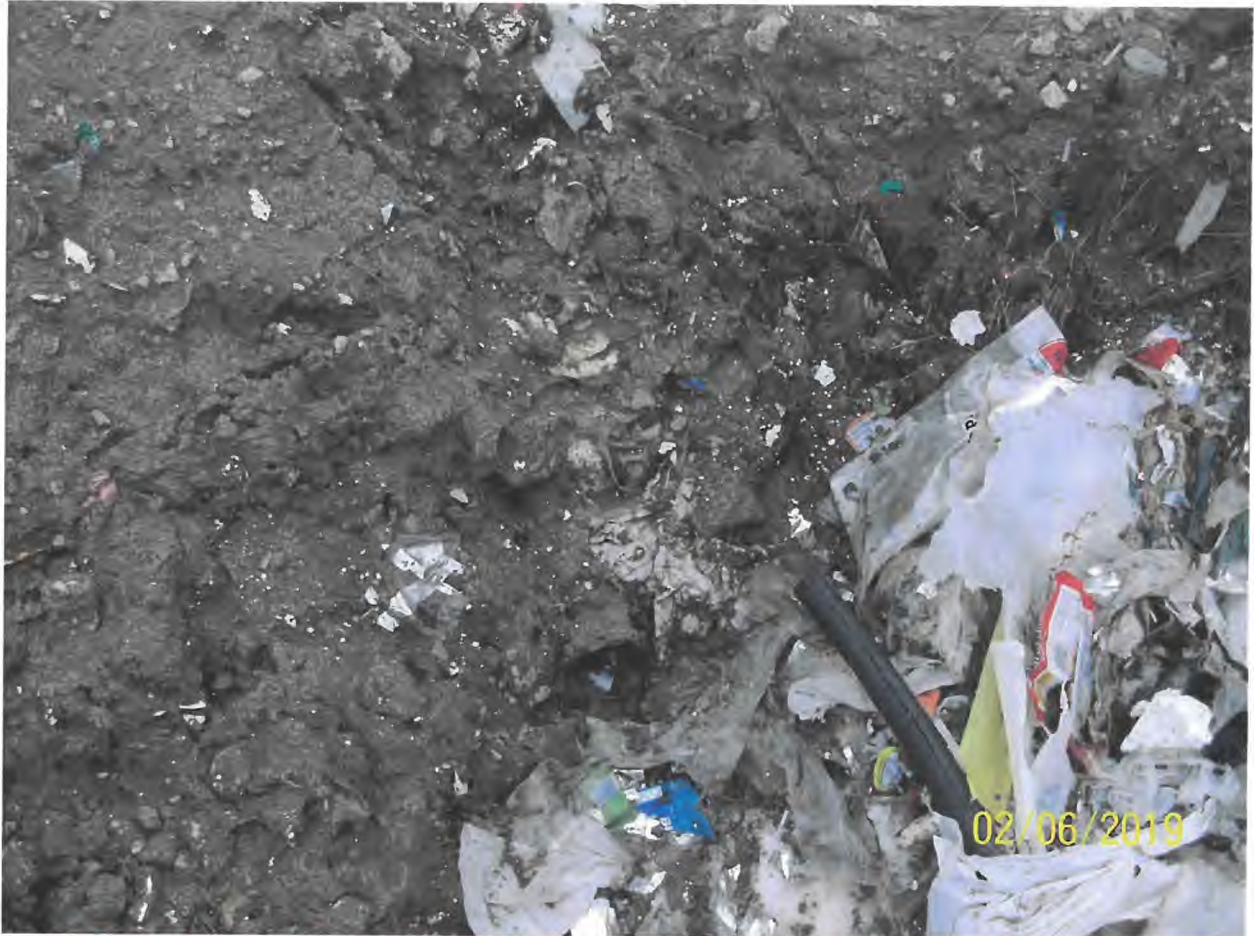
7) Broader view of the outlet end of the drain pipe displayed in photograph #6. Some of the excessive litter accumulated in the pond can be seen in this photograph.
